Refer to: HSA-10/CC-47B

TRITON CONCRETE END TREATMENT (PIN & LOOP PCMB)

Figure 1. Summary of Results - TRITON Barrier TL-3 End Treatment System Test 01-7605-008

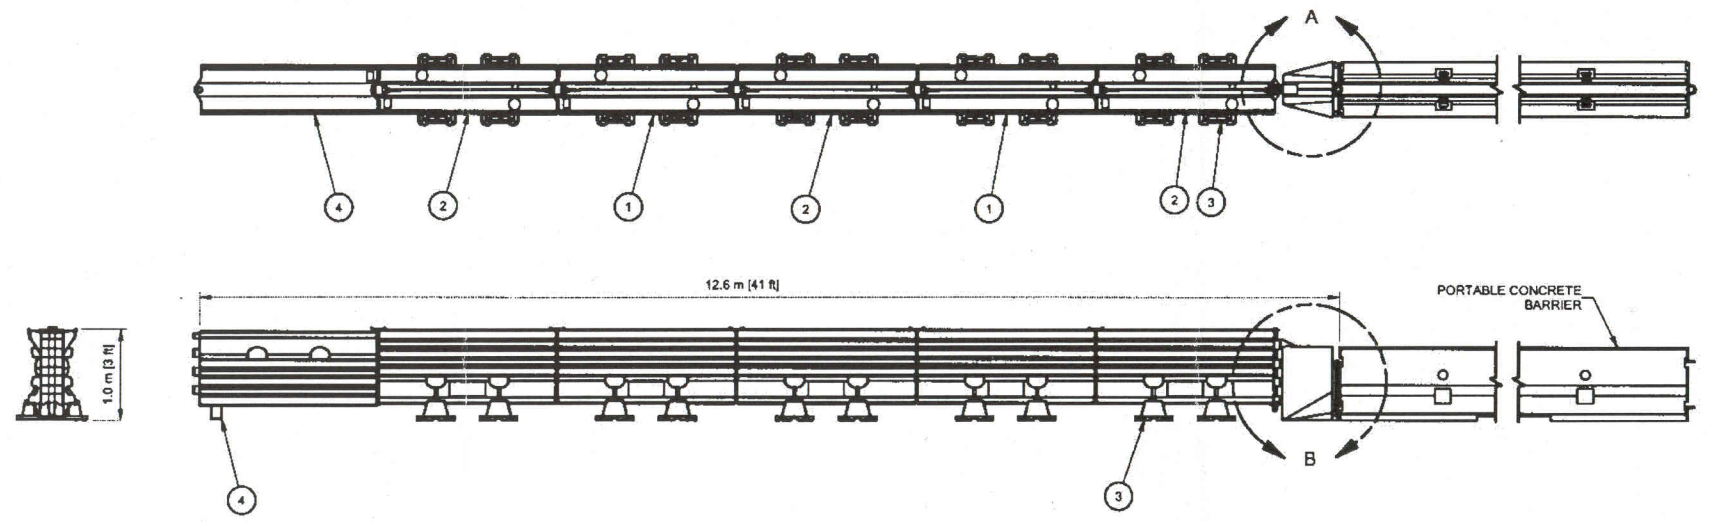
SCALE: 1=50 DRAWING NO: 3595500-0000 SHEET 1 of 2 REV

THE DEPICTED TRITON CONCRETE END TERMINAL PLUS TRANSITION IS A NARROW, NON-REDIRECTIVE, GATING CRASH CUSHION. IT HAS BEEN CRASH TESTED FOLLOWING THE GUIDELINES IN NCHRP 350 TL-3 (100 km/h). ITS IMPACT PERFORMANCE IS SIMILAR TO A SAND-FILLED INERTIAL BARRIEL ARRAY. AS A CONSEQUENCE, CARE MUST BE USED IN ITS APPLICATION IN THE FIELD. IT IS RECOMMENDED THE TRITON CONCRETE END TERMINAL ONLY BE USED TO PROTECT PORTABLE (UNANCHORED) CONCRETE BARRIER AT SITES WHERE THE CHANCE OF HIGH ANGLE, HIGH SPEED IMPACTS IS LOW. WHEN THESE TYPES OF ANGLED IMPACTS MAY OCCUR, A REDIRECTIVE CRASH CUSHION, SUCH AS THE QUADGUARD SYSTEM, SHOULD BE INSTALLED INSTEAD.

The design, shown as Enclosure 1, consists of five TRITON barrier segments filled with water and set 178 mm off the ground on plastic support pedestals. The sixth and lead segment is inverted and left empty. It is installed 130 mm above the ground and connected to the first water-filled segment by a metal bracket. The rearmost segment is pinned to a foam-filled steel transition section (Enclosure 2) that is itself pinned to the first of two unanchored, 3-m long concrete barrier segments. Based on prior discussions with Mr. Richard Powers of my staff, it was mutually agreed beforehand that one test would be sufficient to assess the crashworthiness of TRITON Concrete End Treatment System (TCETS) when used as a crash cushion to shield the end of 3-m long temporary concrete barrier segments.

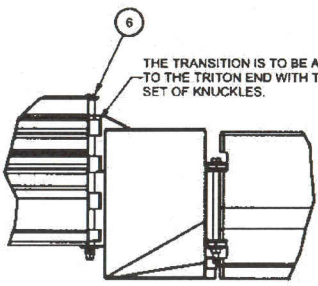
DETAIL A
SCALE 1/25

THE TRITON TL-3 END TERMINAL IS ATTACHED TO THE LOOPS IN THE END OF THE PORTABLE CMB.

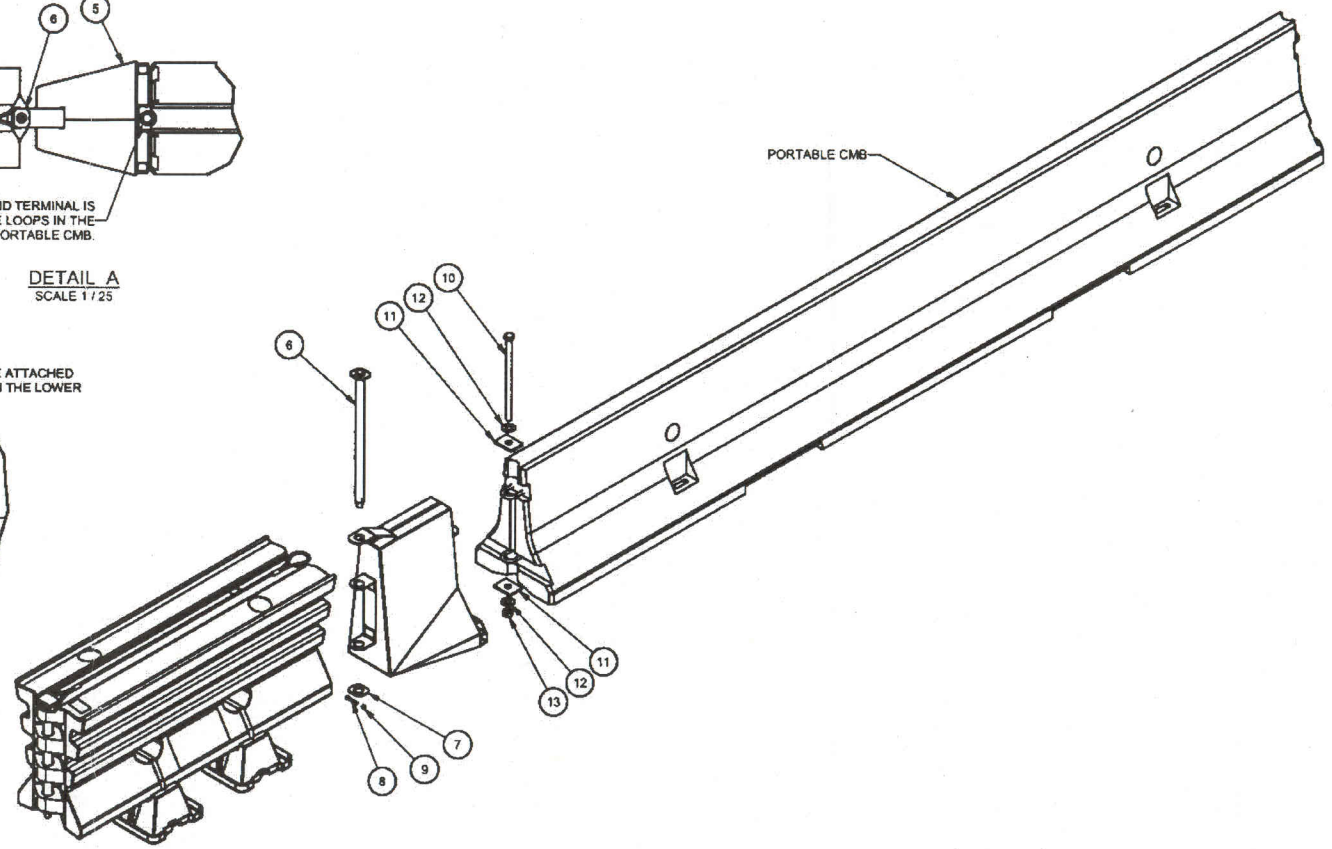
DETAIL B
SCALE 1/25

THE TRANSITION IS TO BE ATTACHED TO THE TRITON END WITH THE LOWER SET OF KNUCKLES.

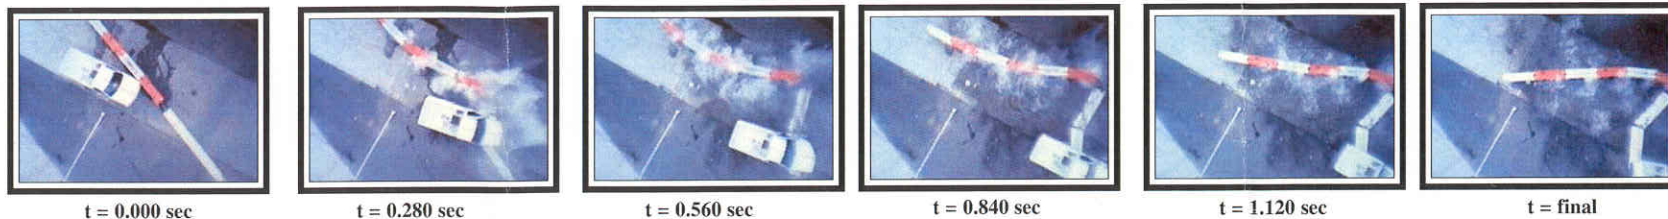
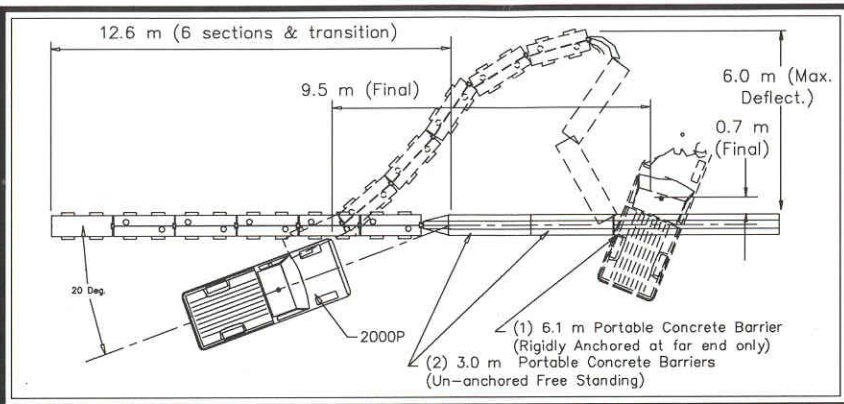
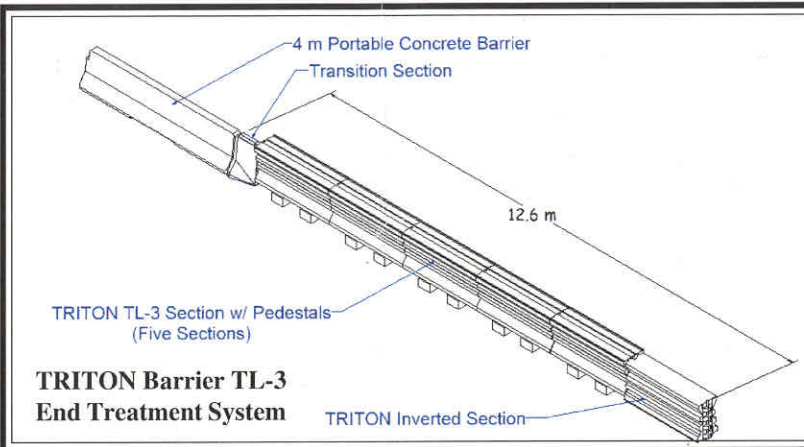
Test Agency E-TECH Testing Services, Inc.
 Test Designation NCHRP 350 Test 3-44 (Modify)
 Test No. 01-7605-008
 Date 11/13/03

Type Energy Absorption Systems, Inc.
 TRITON BARRIER Concrete
 End Treatment System
 Installation Length 12.6 m - (6) Sections
 Size and/or dimension and material
 of key elements 1981 mm Section
 Length, 178 mm Pedestal Height
 Polyethylene Plastic with
 transition to (2) 3.0 m unanchored
 CMB and 6.1 m anchored CMB
 Foundation and Anchoring Dry concrete, unanchored

Speed (km/h) 99.7
 Angle (deg) 20
 Impact Severity (kJ) 766.5

Exit conditions		
Speed (km/h)	N/A	
Angle (deg)	N/A	
Occupant Risk Values	Primary*	Secondary
Impact Velocity (m/s)		
x-direction	12.5*	12.3
y-direction	4.1*	3.6
Ridedown Acceleration (g's)		
x-direction	-16.1*	-18.9
y-direction	-120.2*	-11.4
European Committee for Normalization (CEN) Values		
THIV (km/h)	47.9	46.1
PHD (g's)	120.6	20.1
ASI	3.6	1.5
Post-Impact Vehicular Behavior (deg - rate gyro/film)**		
Maximum Roll Angle	-54.9/-55	-55.0
Maximum Pitch Angle	22.9/75	22.9
Maximum Yaw Angle	-28.7/-55	-29.1
Test Article Deflections (m)		
Dynamic	6.0	
Permanent	6.0	
Vehicle Damage (Primary Impact)		
Exterior		
VDS	LFQ-5	
CDC	11LDEN4	
Interior		
VCDI	AS1020000	
Maximum Deformation (mm)	272

* Spurious signal on primary accelerometer due to floorboard buckle.
 ** Gyro measurements relative to bed, film measurements relative to cab.

Test 3-44 was conducted with the center of the pickup truck aimed at the center of the first concrete barrier segment. The test vehicle came to rest with its severely bent frame straddling one of the displaced concrete barrier segments. Enclosure 3 is the data summary sheet for the test.

waived for test 3-44. As can be seen on the test summary sheet, the OIV in your test was 12.3 m/sec, higher than the 12 m/s permissible for all other crash cushion tests. You noted also the occupant compartment deformation was 272 mm, significantly higher than the generally accepted limit of 150 mm, but that it was in a location where "it would not be life-threatening." As noted in Mr. Griffith's earlier acceptance letter, occupant compartment intrusion likely to cause serious occupant injury is a subjective factor (as are allowable vehicular roll, pitch and yaw angles), so I am again willing to consider TCETS acceptable for use on the National Highway System (NHS) with unanchored pin and loop concrete barrier segments of any length. However, it should be used only at locations where high-speed impacts are unlikely, penetration behind the barrier is acceptable, and use of a redirecting impact attenuator is not feasible for reasons other than cost or convenience.
